# Transect survey for mapping of dangerous pylons and detecting mortality due to electrocution and collisions with power grid in Albania

(Action A3)

AOS 2019

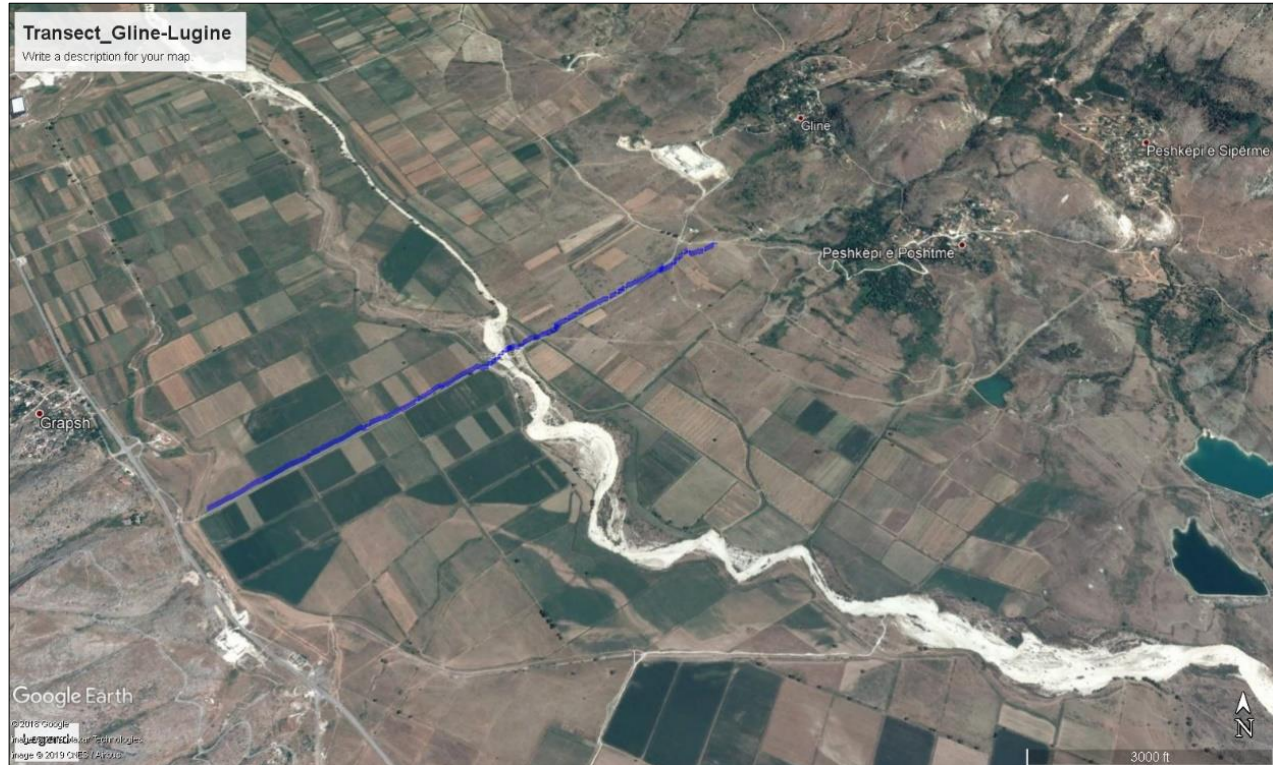
Figure 2. Glinë-Luginë transect (3.8 km).

This transect (Fig. 2) has a total length of 3.8 km and follows a secondary road that connects Peshkëpi village with the main road. Alongside this road are located medium voltage pylons with a height of 7 meters. Due to plain relief we didn't have any difficulties on monitoring all the pylons along this transect.

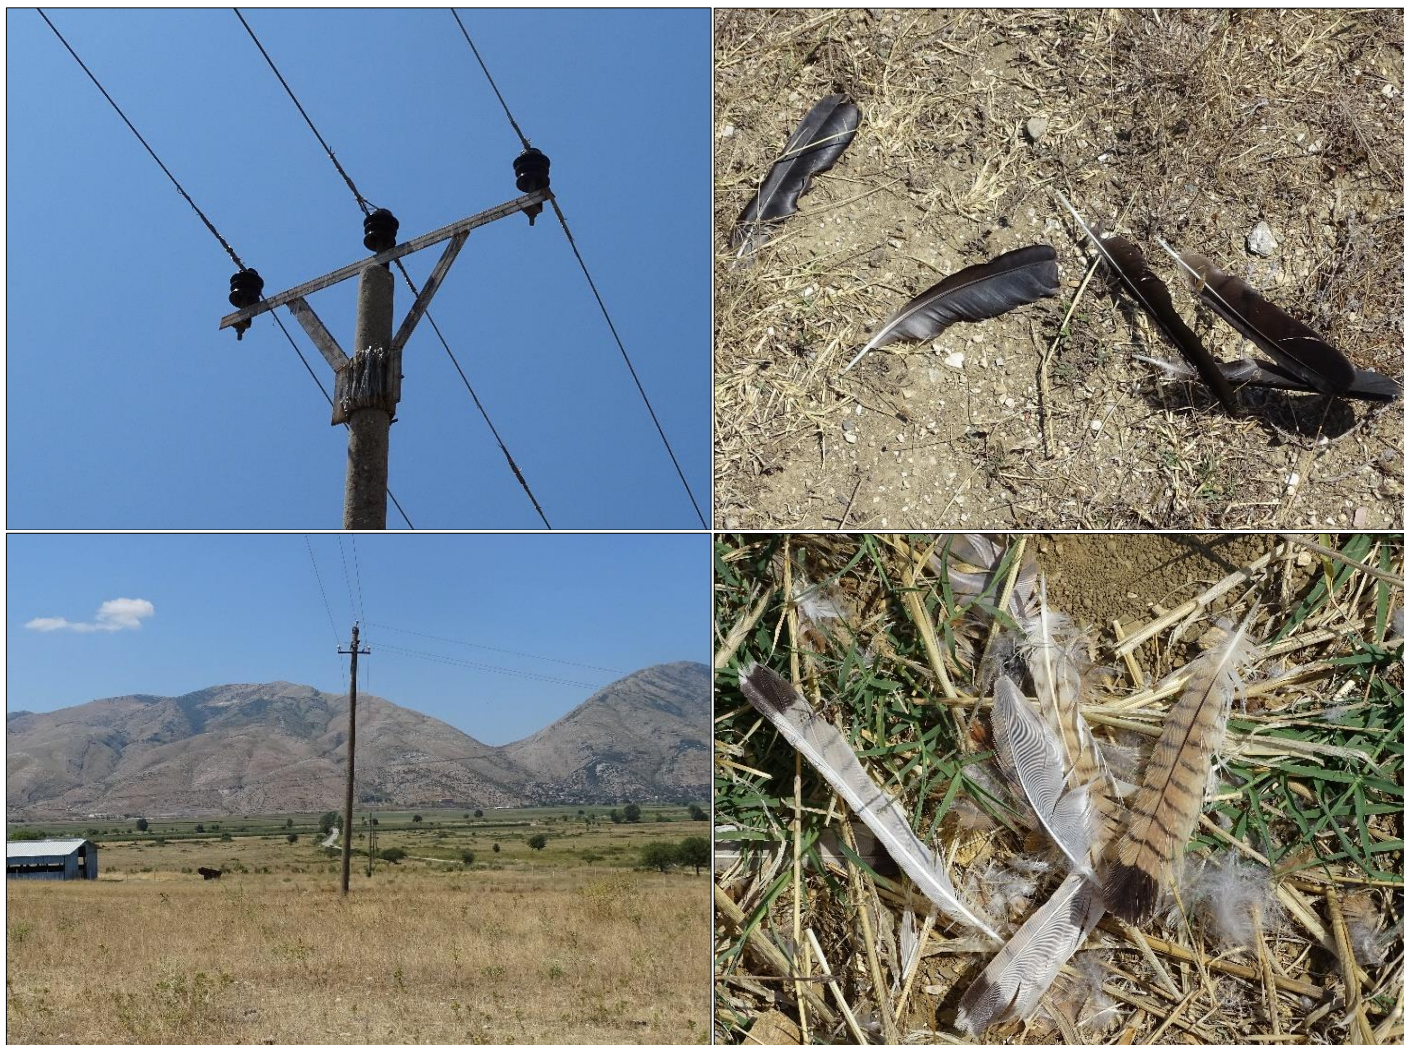
Figure 3. Transect survey of Glinë-Luginë transect, electric poles, powerlines and feathers from Hooded Crow and Lesser Kestrel

During our monitoring on this transect we found limited evidences of a Corvid (most probably Hooded Crow) being electrocuted (Fig. 3 – up right) and a Lesser Kestrel being collided with the power lines (Fig. 3 - down right).

Feathers of a Hooded Crow were found under an electric pole while feathers of Lesser Kestrel were found under the power lines. It is very likely that the Hooded Crow was electrocuted while perching at the power pylon while the Lesser Kestrel has collided with the power lines.

- **at a small segment of the power line, very close to the nest of the Egyptian Vulture in Peshkepi-Radat in order to avoid any potentially danger for collision of the Egyptian Vultures using this nest and the territory.**
- **The insulation of dangerous electric poles and the installment of bird diverters in the power grid Gline-Drino valley for avoiding respectively electrocution and collision.**

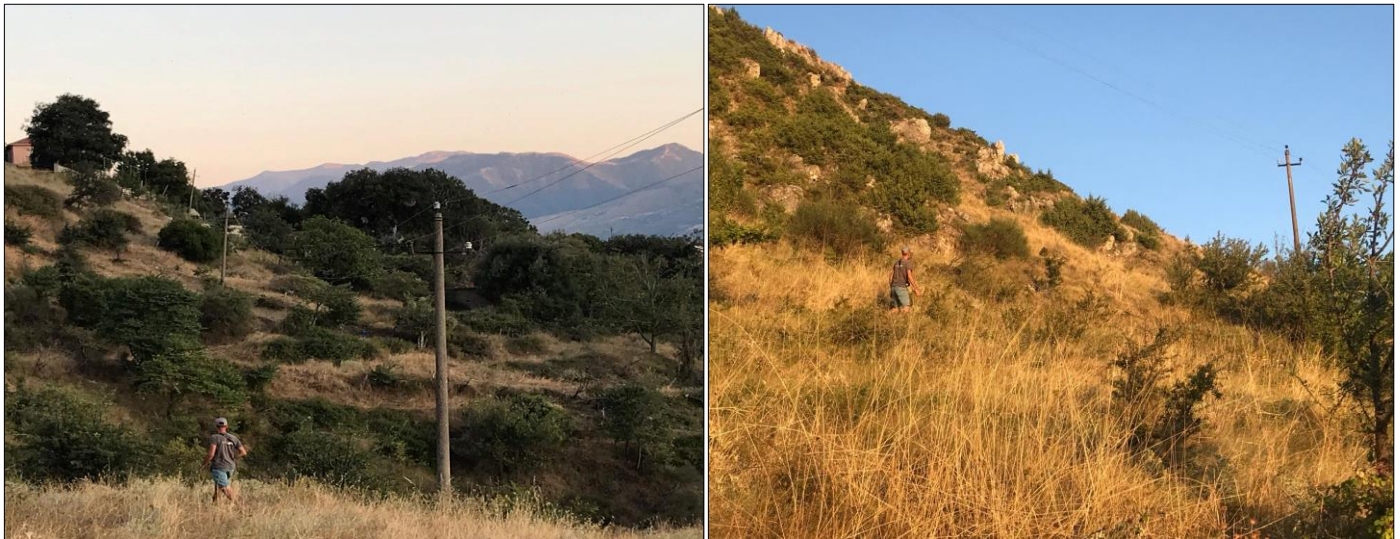
Figure 5. Monitoring of Vllaho-Goranxi – Glinë transect and Monitoring of Vllaho-Goranxi – Glinë transect.

This transect (Fig. 4) has a total length of 2.8 km. The topography of this area is mountainous and rugged while the vegetation cover is represented by xerophilic vegetation (Fig. 5). The terrain and the vegetation cover makes the power line survey difficult as we couldn't follow the power lines closely. No carcasses or remains of dead birds were recorded in this transect.

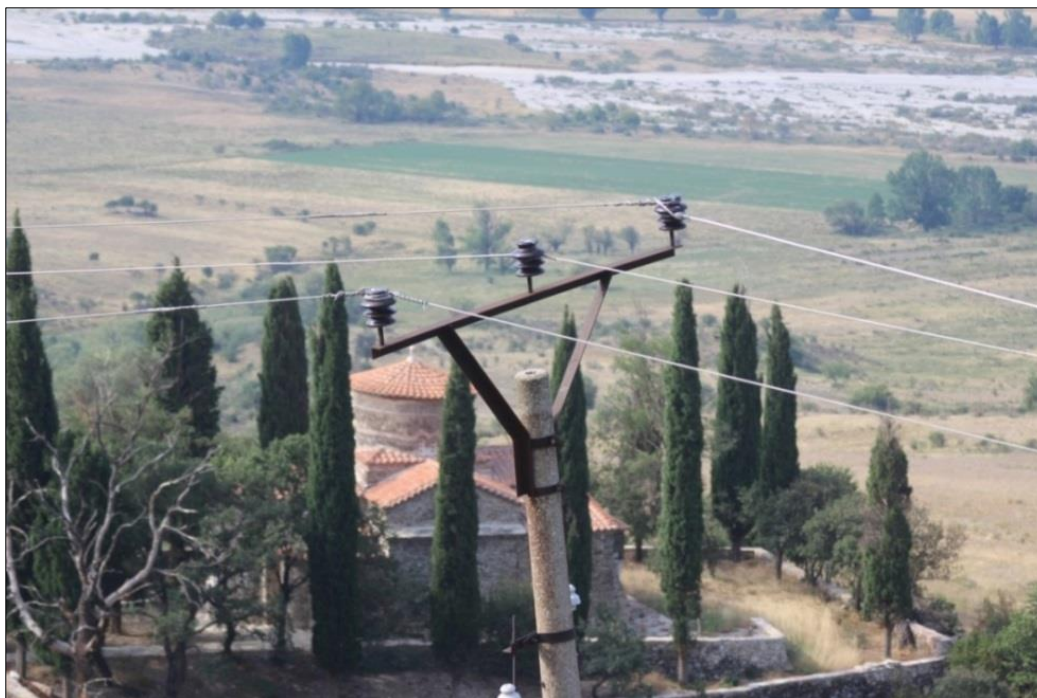
Figure 7. Medium voltage pylon. Peshkëpi-Radat.

Peshkëpi–Radat powerline (Fig. 6) has a total length of 5.6 Km and it is located at the central part of the Egyptian Vulture territory of Peshkepi-Radat, as well as very close to the nest. The monitoring of this transect was difficult because of the topography of the area and the presence of xerophilic vegetation cover (Fig 7 and 8). No carcasses or remains of dead birds were recorded in this transect.

**Despite the absence of carcasses, its vicinity with the nest make some sections of this powerline potentially dangerous for collision of the Egyptian Vultures using this nest and the territory.**

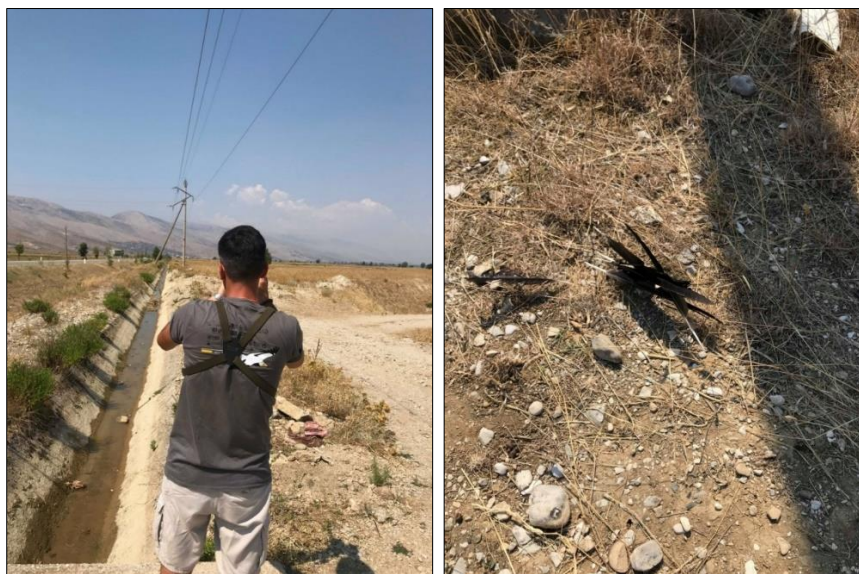
Figure 11. Bird feathers found during the survey of Kakavijë-Jogurcat transect

Kakavijë-Jogurcat (Fig. 10) transect has a total length of 5.7 km and it lies in a plain area, south of the EV occupied territories. On this transect we have recorded some black feathers (Fig. 11). Nevertheless, we could not arrive in a conclusion about this finding. It could be a case of collision but the evidence is not sufficient.

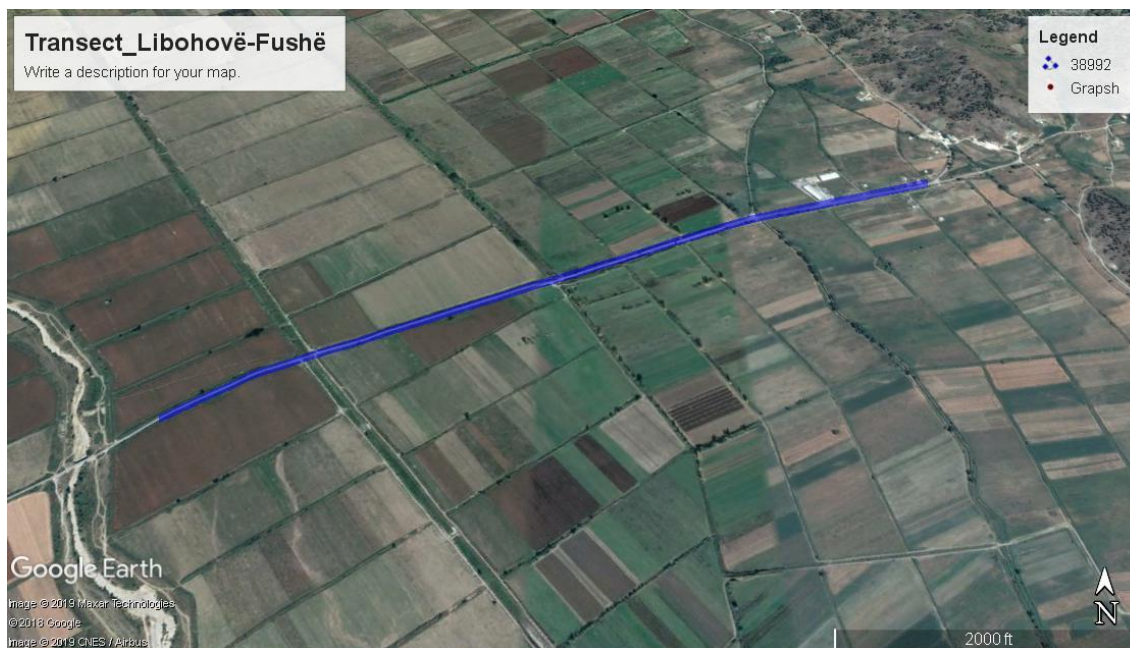
Figure 12. Libohovë – Fushë transect (3.6 km).

Libohovë-Fushë transect (Fig. 12) has a length of 3.6 km. During the monitoring of this transect we observed many migratory birds resting on the wires (Fig. 13). No carcasses or remains of dead birds were recorded.

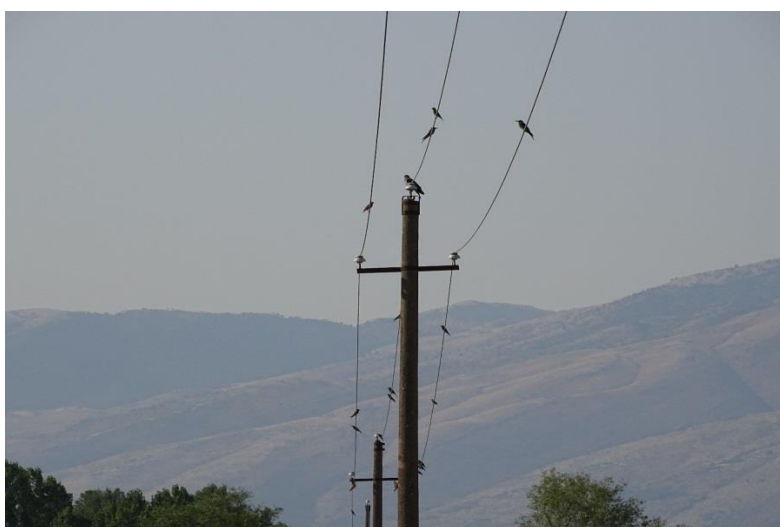
Figure 13. Birds resting on power lines

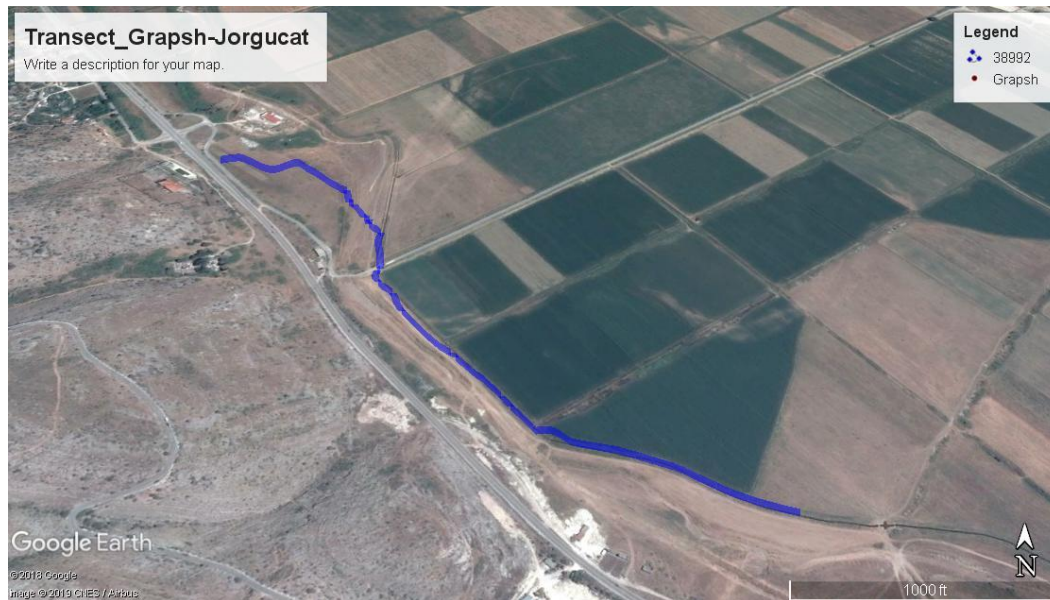
Figure 14. Jorgucat – Grapsh transect (1.9 km).

Jogurcat-Grapsh transect (Fig. 14) has a length of 1.9 km. No carcasses or remains of dead birds were recorded in this transect despite the presence of dangerous powerlines (Fig. 15).

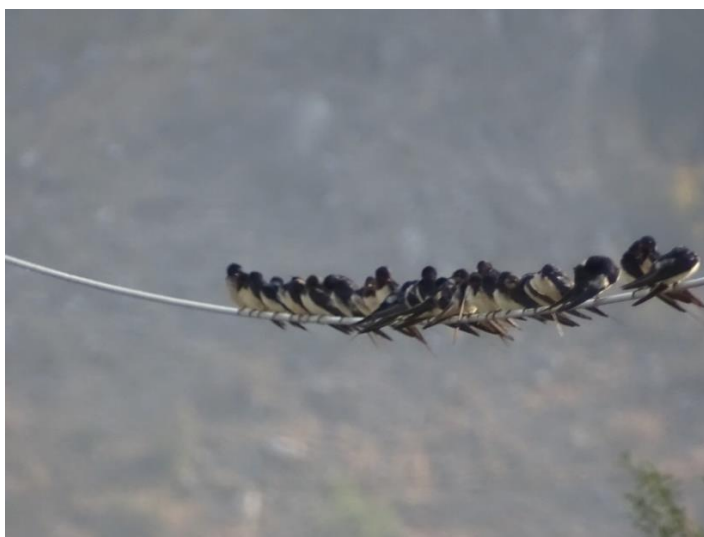
This transect (Fig. 16) has a total length of 4.6 km. It lies entirely in the village of Nepravishta. During the monitoring on this transect we didn't record any carcasses or remains of dead birds. Flocks of Barn Swallows (*Hirundo rustica*) were observed in migration (Fig. 17).

Figure 17. Barn Swallows (*Hirundo rustica*) on power lines.

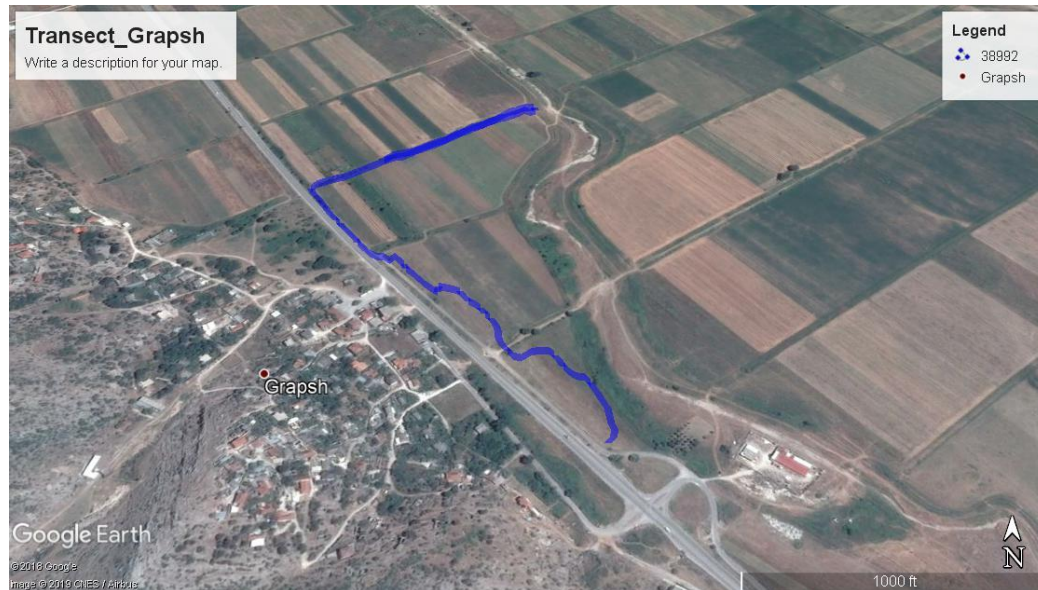
Figure 18. Grapsh-Fushë transect (2.2 km).

Grapsh – Fushë transect (Fig. 18) has a total length of 2.2 km. On this short transect we didn't record any carcasses or remains of dead birds. Birds of prey were using the poles as perching sites (Fig. 19).

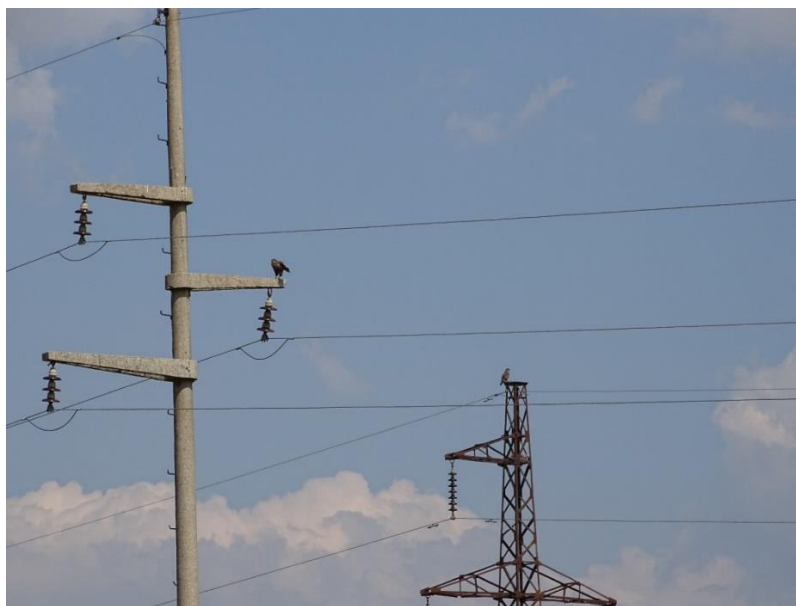
Figure 19. Common Buzzard and Short-toed Eagle in Grapsh-Fushe

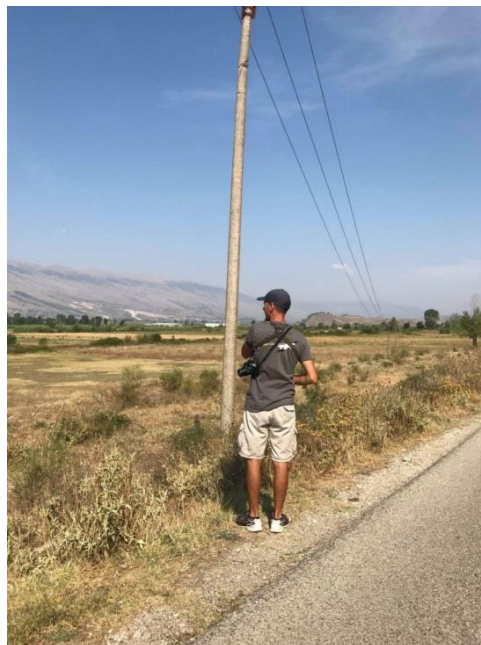
Bulo-Fushë transect (Fig. 20) has a total length of 3.7 km. We didn't record any carcasses or remains of dead birds on this transect (Fig. 21).

Figure 21. Survey in Bulo-fushe transect

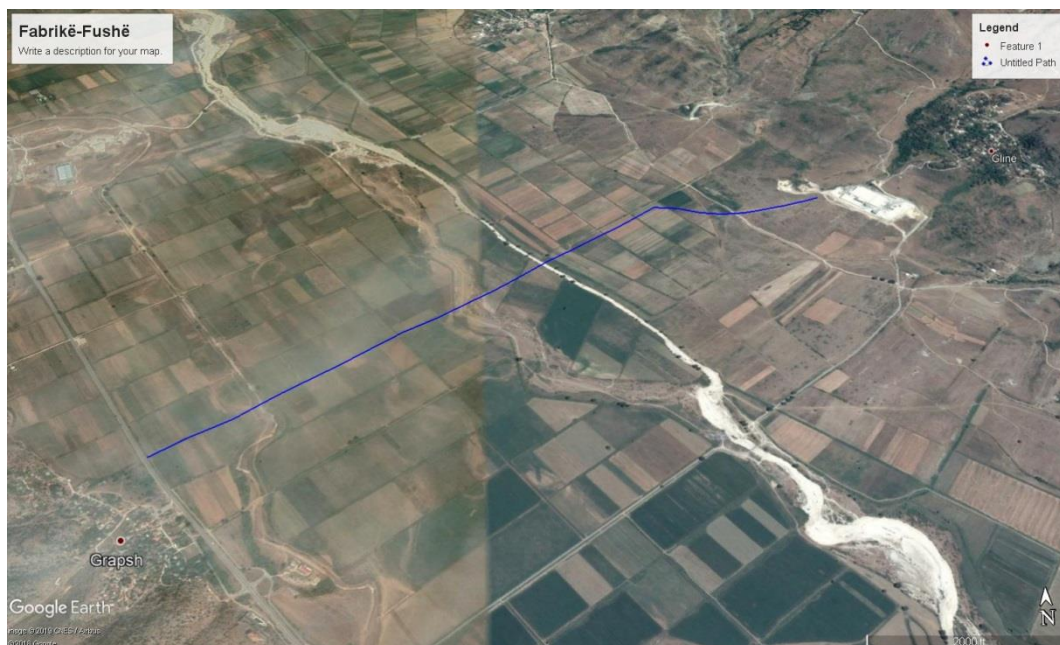
Figure 22. Glina Factory – Drino valley transect (4 km)

We carried out another survey of the power lines in Drino valley, this time following another transect (Fig. 22) with a total length of 4 km. We didn't record any carcasses or remains of dead birds. During the survey we met a local shepherd who also hadn't seen any carcasses or remains of dead bird.

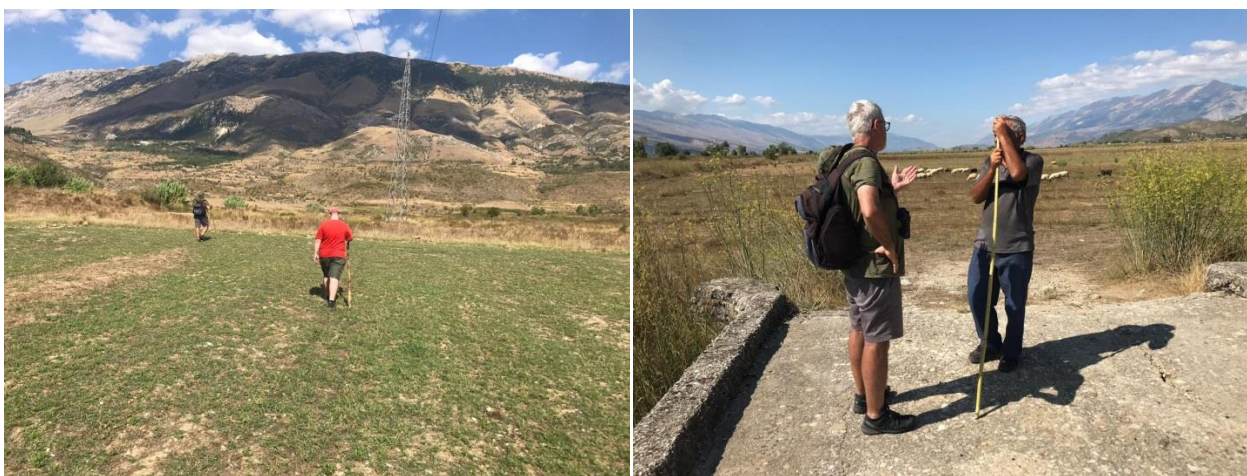
Figure 23. Monitoring of Glina Factory – Drino valley transect and Talking with locals.

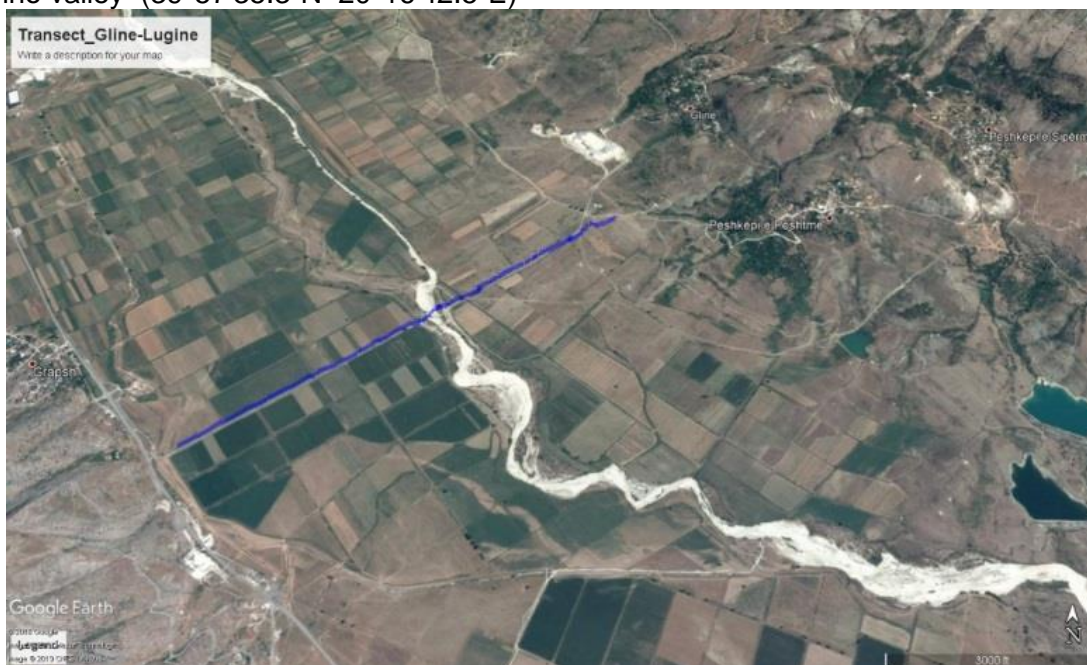
Figure 24. Glinë – Drino valley transect.

The power grid at Drino plain seems more problematic due to the presence of dangerous electric pylons and a heavy network of power lines (*see the most dangerous power lines in Annex 1*). Our surveys in this part of the valley could not find any carcasses perhaps due to the low intensity of the observations on the specific power lines. Nevertheless, the surveys here, and more specifically in the transect Glinë – Drino valley, provided some evidences of potential cases of electrocution and collision of birds.

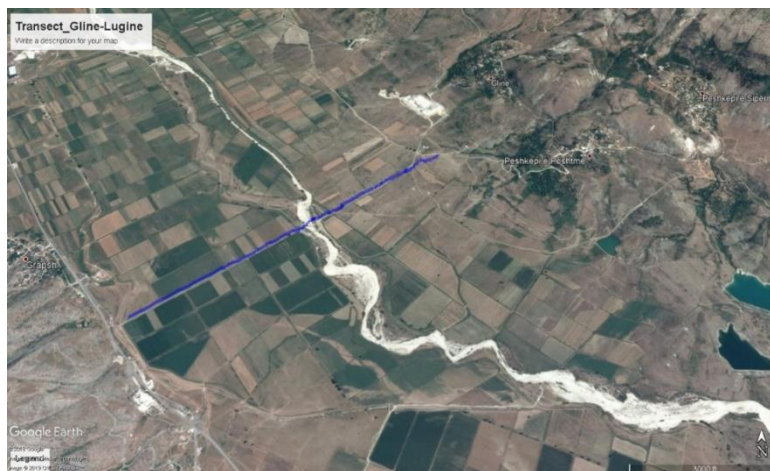
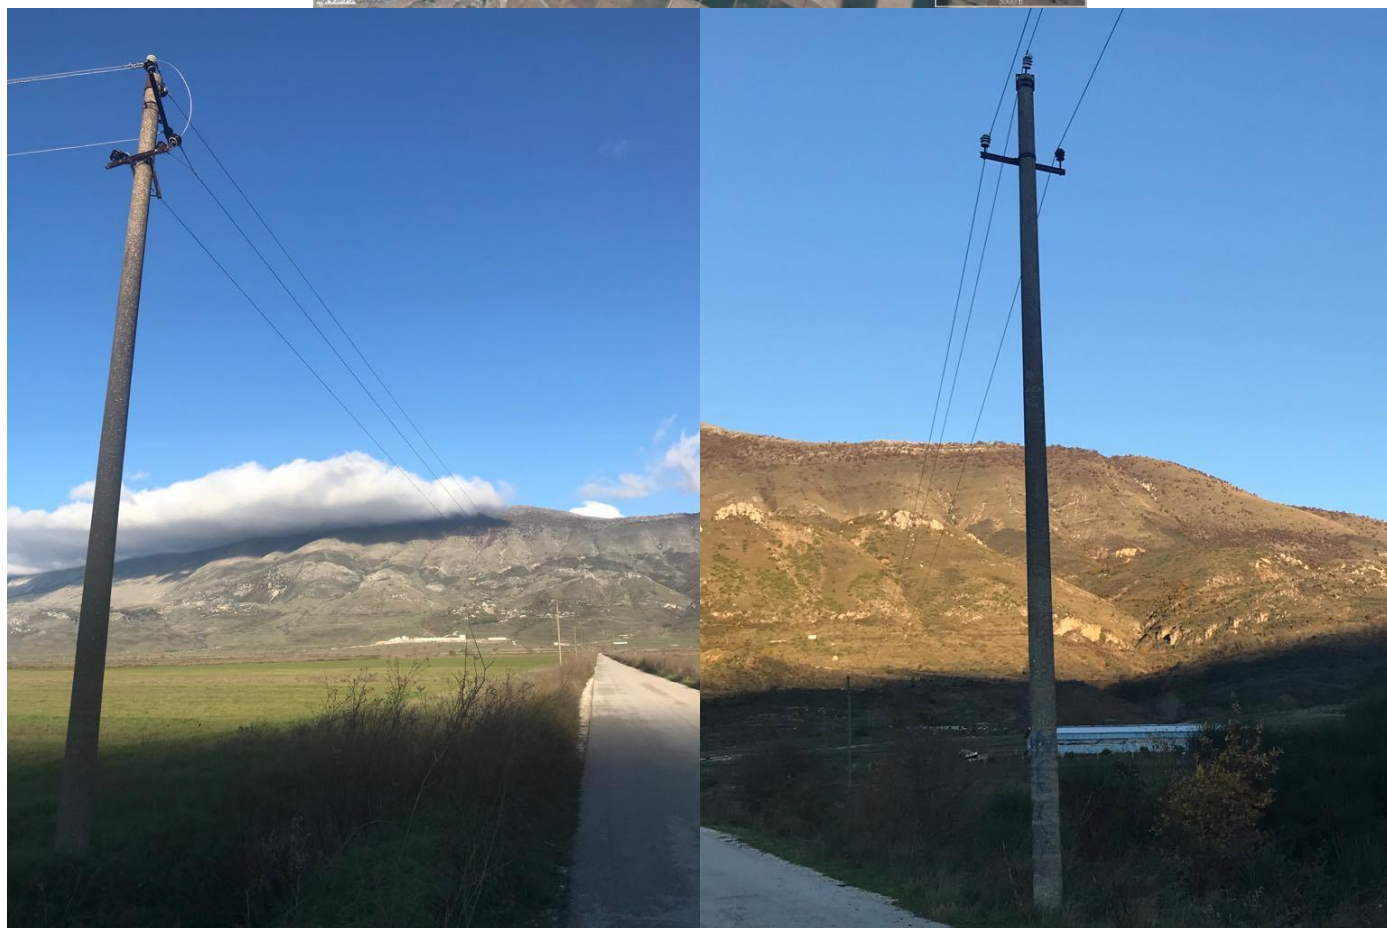
Figure 29. Gline-Drino valley power line recommended for insulation and installment of bird diverters

Despite the absence of very strong evidence of electrocution or collision, it is obvious that some of the power lines, especially those located in the floodplain, are dangerous for many birds of prey due to the fact that (i) there are no visual barriers (vegetation) along those power lines to make birds aware of the risk of collision and (ii) these areas are used by many birds of prey as perching places or feeding sites as well as corridors for their migration.

The power line of Gline-Drino valley transmits medium voltage, its length of approximately 3 Km and has 29 concrete electric pylons (*see for pictures of this power line in Annex 2*).
